**Test Report No: RJ9434P-1**

**TEST REQUESTED:** Freeze-thaw test per Method A of ASTM E2485/E2485M-13(Reapproved 2018), *Standard Test Method for Freeze/Thaw Resistance of Exterior Insulation and Finish Systems (EIFS) and Water Resistive Barrier Coatings.*

**FREEZE-THAW TEST PER METHOD A OF ASTM E2485/E2485M-13(Reapproved 2018)**

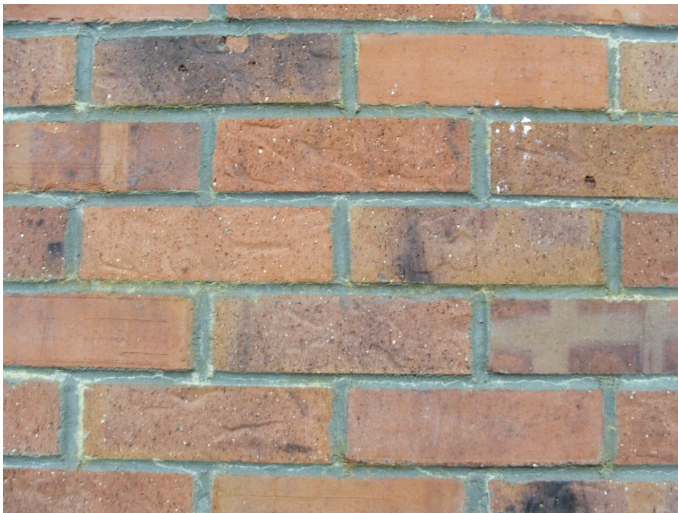
1/2" Thin Brick Sample

No deleterious effects such as cracking, crazing, checking, blistering, peeling, delamination, or erosion were observed on any of the samples after 60 freeze-thaw cycles. Photographs showing the results of this test are provided below.

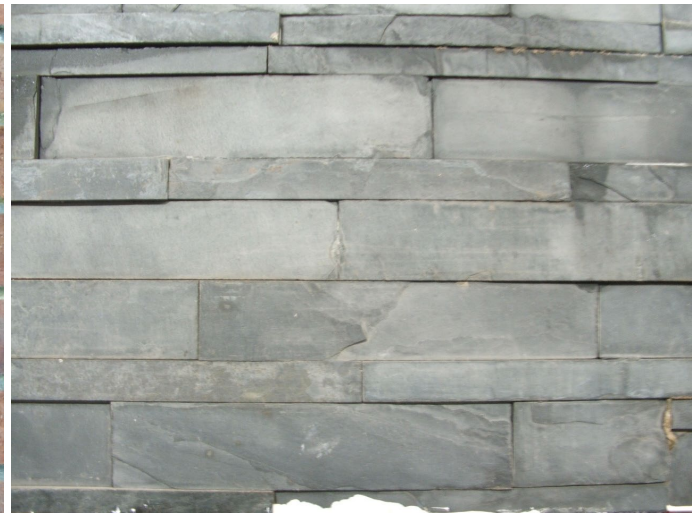
1" Stone Veneer Sample
