# OLD MILL BRICK FIRE TEST REPORT

NFPA 285 TESTING ON EXTERIOR NON-LOAD-BEARING WALL ASSEMBLY CONTAINING OLD MILL BRICK'S PANEL+ INSULATED THIN BRICK VENEER SYSTEM

G104002492SAT-003 R1

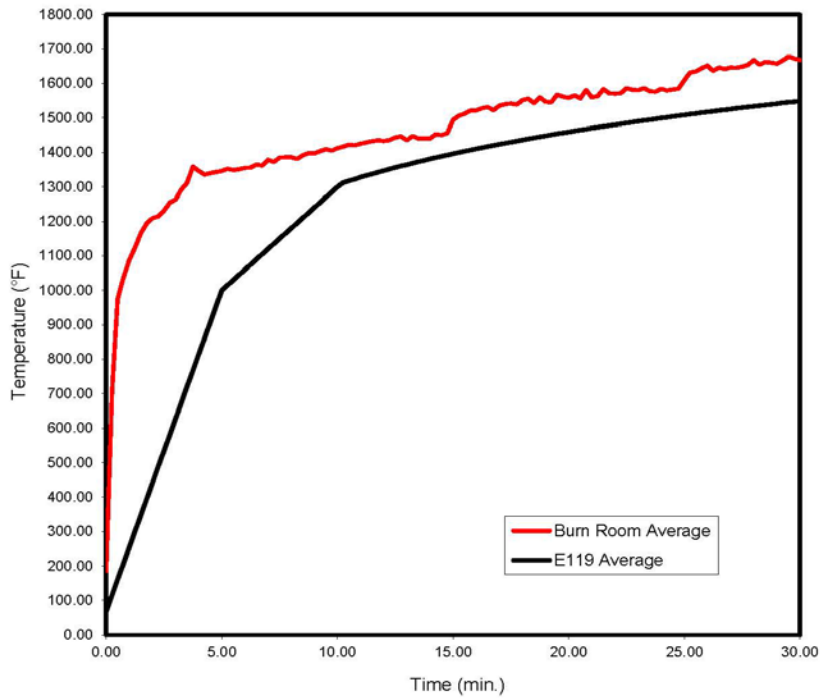
Graph No. 1

Old Mill Brick  
Project No. G104002492SAT-003  
November 12, 2019  
Burn Room Average

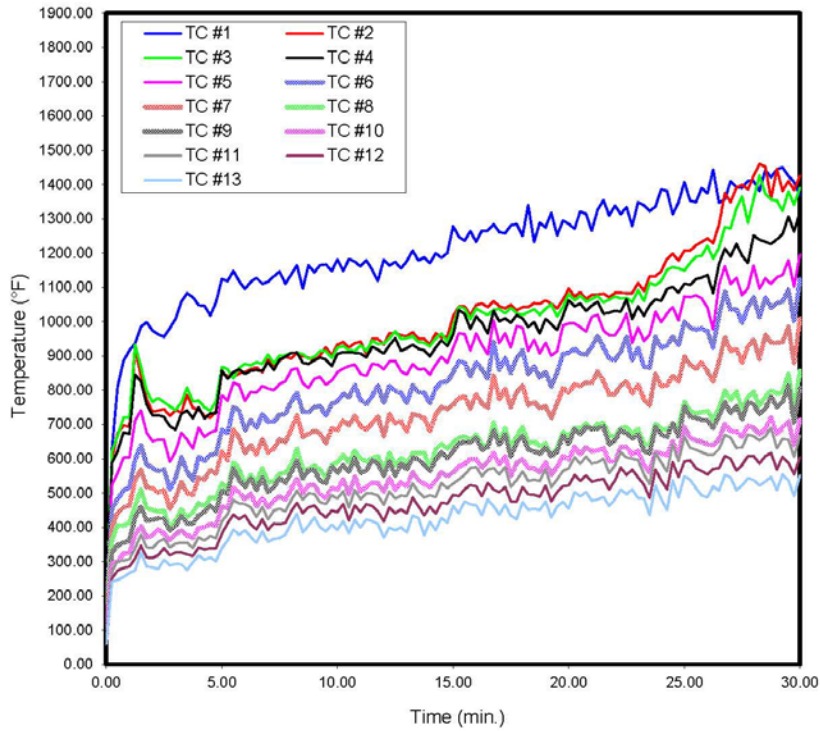
Graph No. 2

Old Mill Brick  
Project No. G104002492SAT-003  
November 12, 2019  
Vertical Face  
TC 1-13

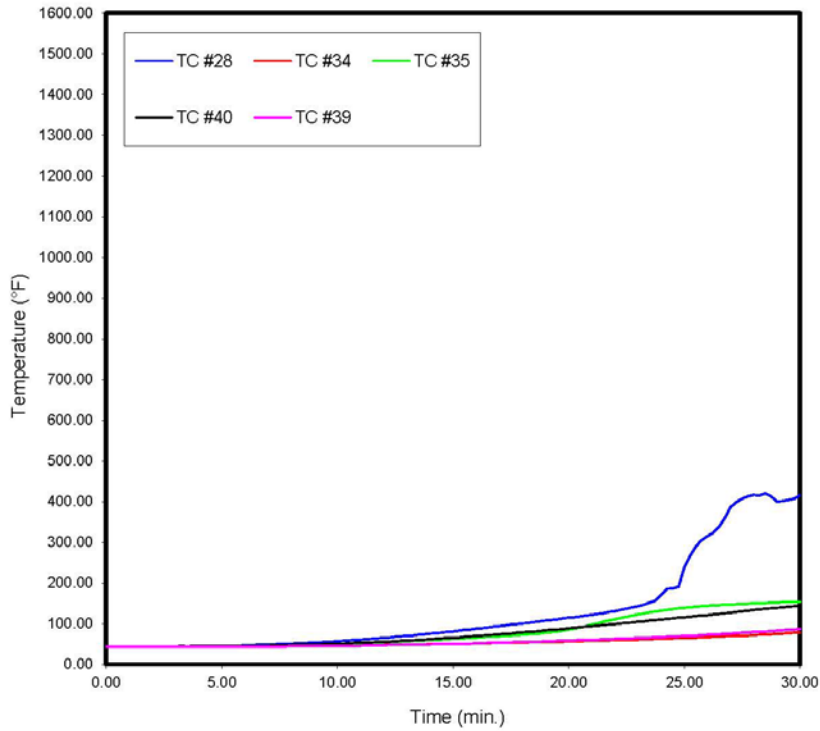
Graph No. 3

Old Mill Brick  
Project No. G104002492SAT-003  
November 12, 2019  
10-ft Air Cavity  
TC 28, 34, 35, 40, 39

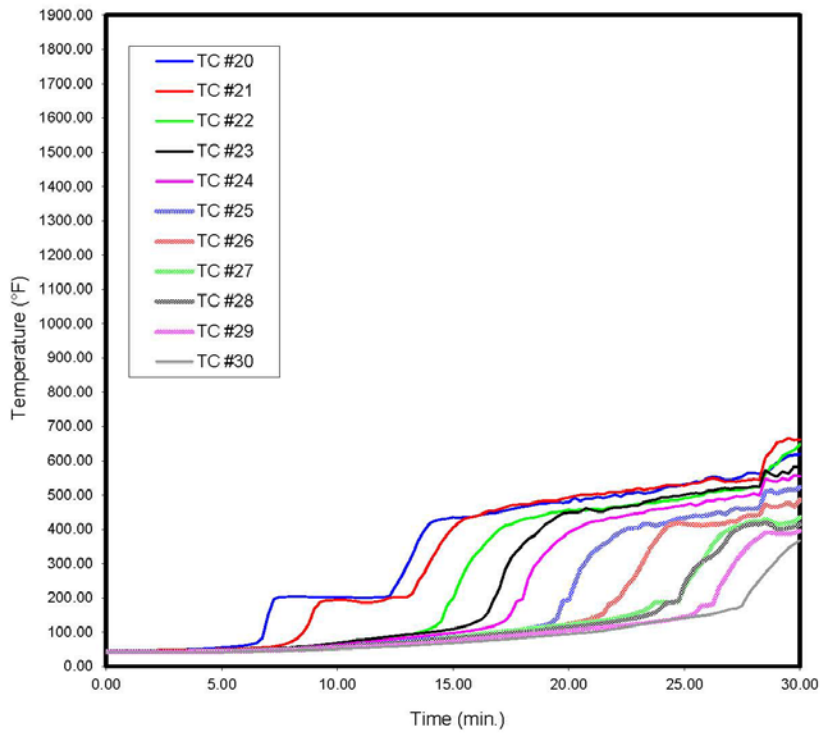
Graph No. 4

Old Mill Brick  
Project No. G104002492SAT-003  
November 12, 2019  
Vertical Air Cavity  
TC 20-30

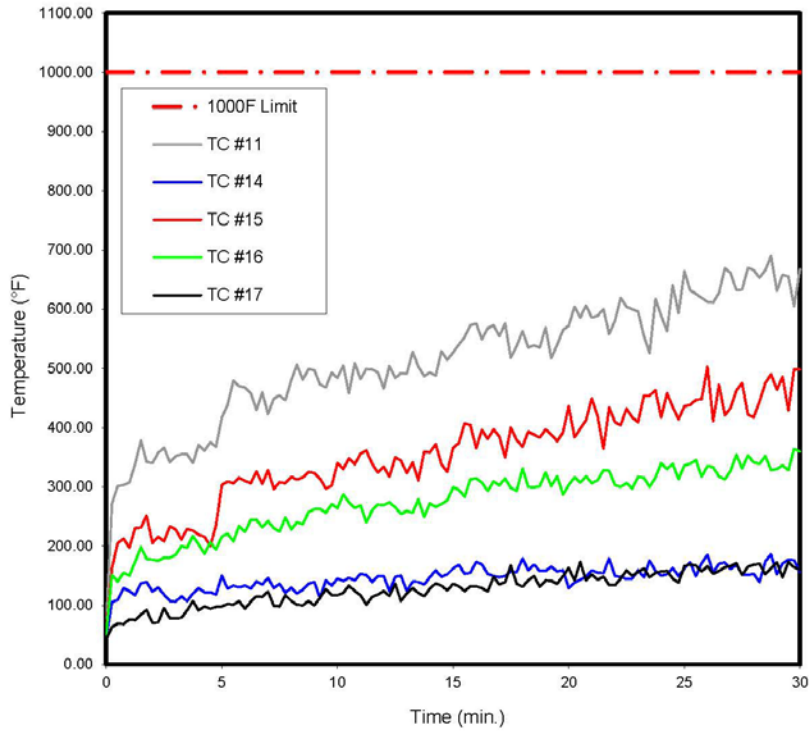
Graph No. 5

Old Mill Brick  
Project No. G104002492SAT-003  
November 12, 2019  
10-ft Front Face  
TC 11, 14-17

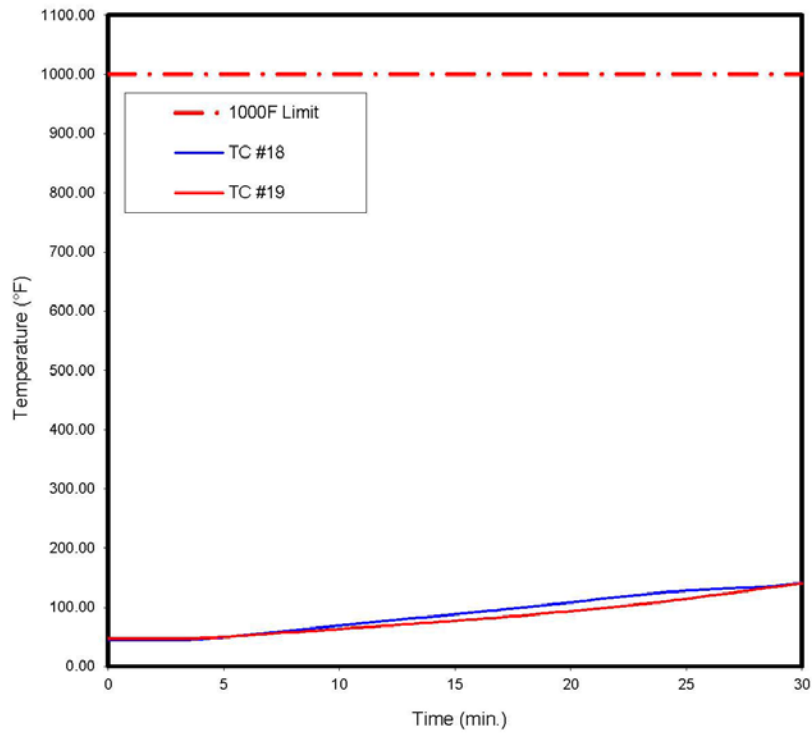
Graph No. 6

Old Mill Brick  
Project No. G104002492SAT-003  
November 12, 2019  
Air Cavity  
TC 18, 19

TEST REQUIREMENTS	TEST RESULTS	PASS/FAIL
Flames did not reach 10 ft. above the window opening header.	Flames did not reach 10 ft. above the window opening header.	<b>PASS</b>
Flames did not reach a lateral distance of 5 ft. from the vertical centerline.	Flames did not reach a lateral distance of 5 ft. from the vertical centerline.	<b>PASS</b>
Flames did not propagate beyond the limits of the first story test room.	Flames did not propagate beyond the limits of the first story test room.	<b>PASS</b>
No visible flaming in the second story test room	No visible flaming in the second story test room.	<b>PASS</b>
TC's 11 and 14-17 (1000°F limit)	TC's 11 and 14-17 did not exceed their 1000°F limit.	<b>PASS</b>
TC's 18-19, 28, and 31-40 (1000°F limit)	TC's 18-19, 28, and 31-40 did not exceed their 1000°F limit.	<b>PASS</b>

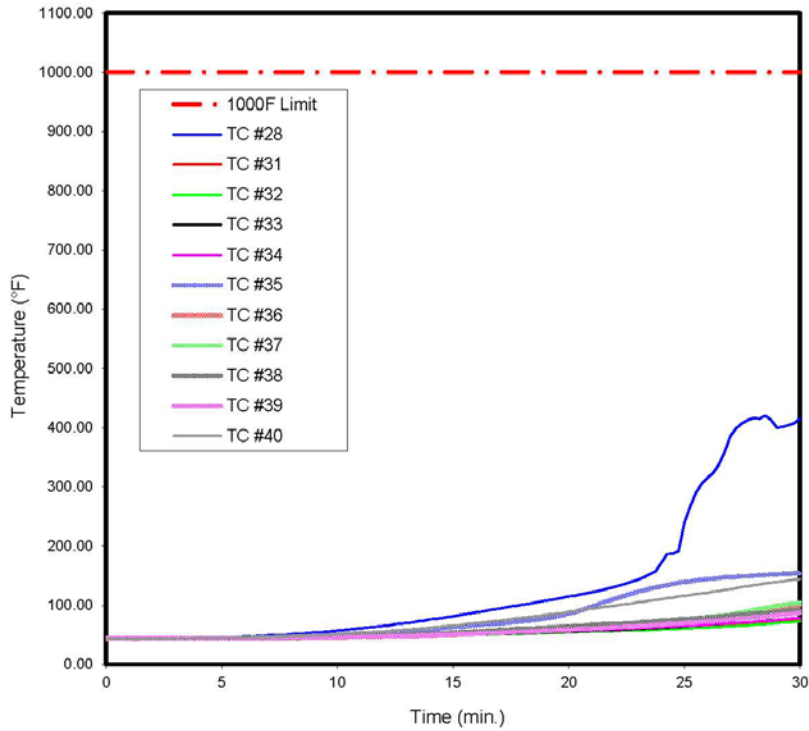
Graph No. 7

Old Mill Brick  
Project No. G104002492SAT-003  
November 12, 2019  
Air Cavity  
TC 28, 31-40

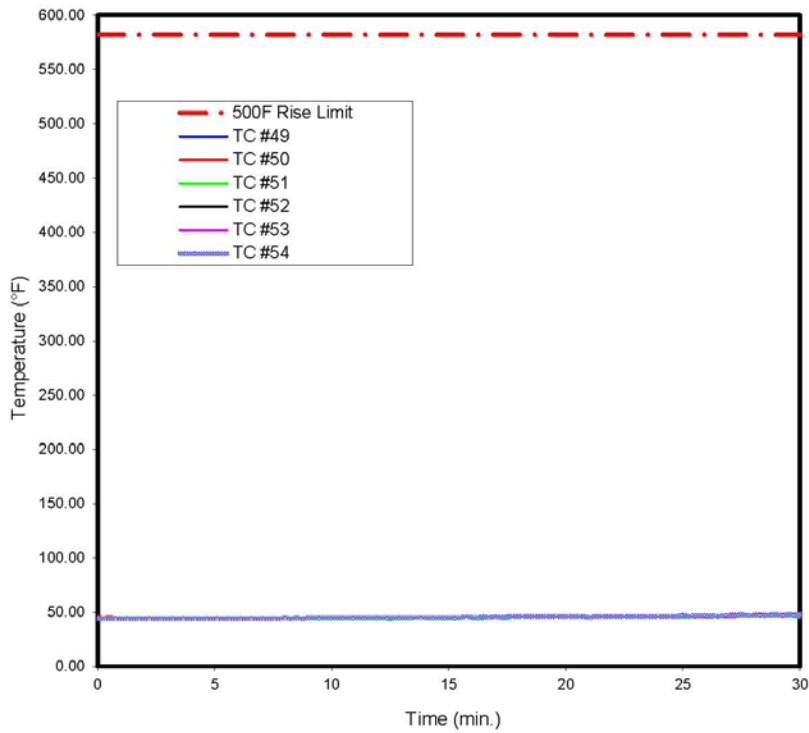
Graph No. 8

Old Mill Brick  
Project No. G104002492SAT-003  
November 12, 2019  
2nd Floor, 1-in from wall  
TC 49-54

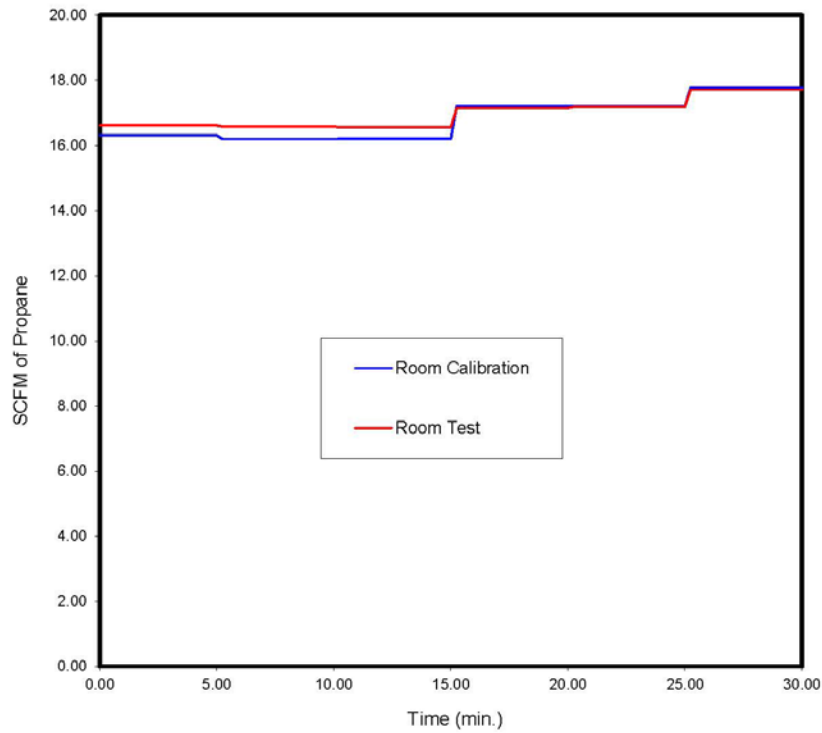
Graph No. 9

Old Mill Brick  
Project No. G104002492SAT-003  
November 12, 2019  
Room Burner Flow Rates

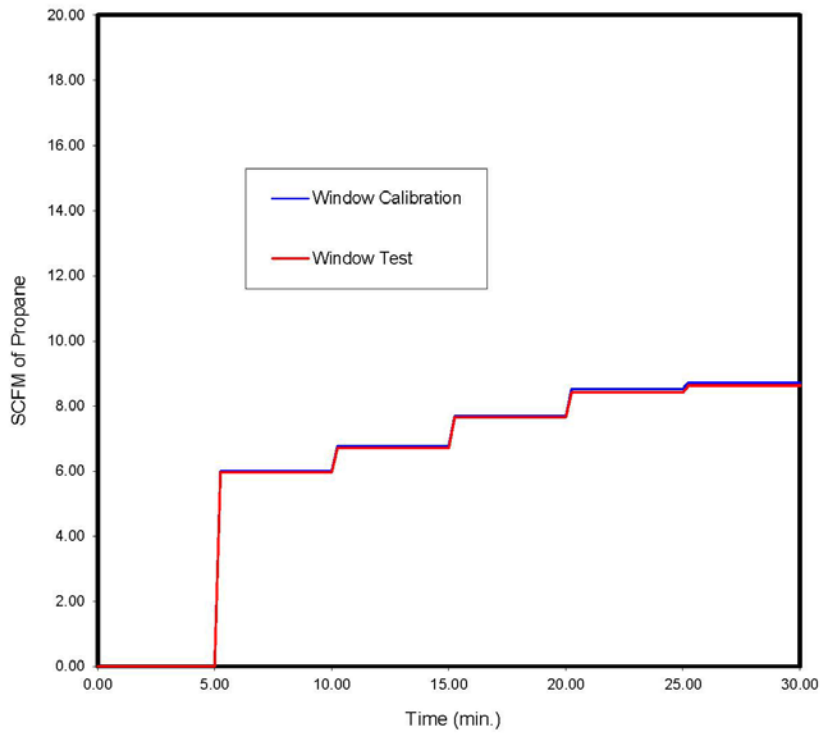
Graph No. 10

Old Mill Brick  
Project No. G104002492SAT-003  
November 12, 2019  
Window Burner Flow Rates

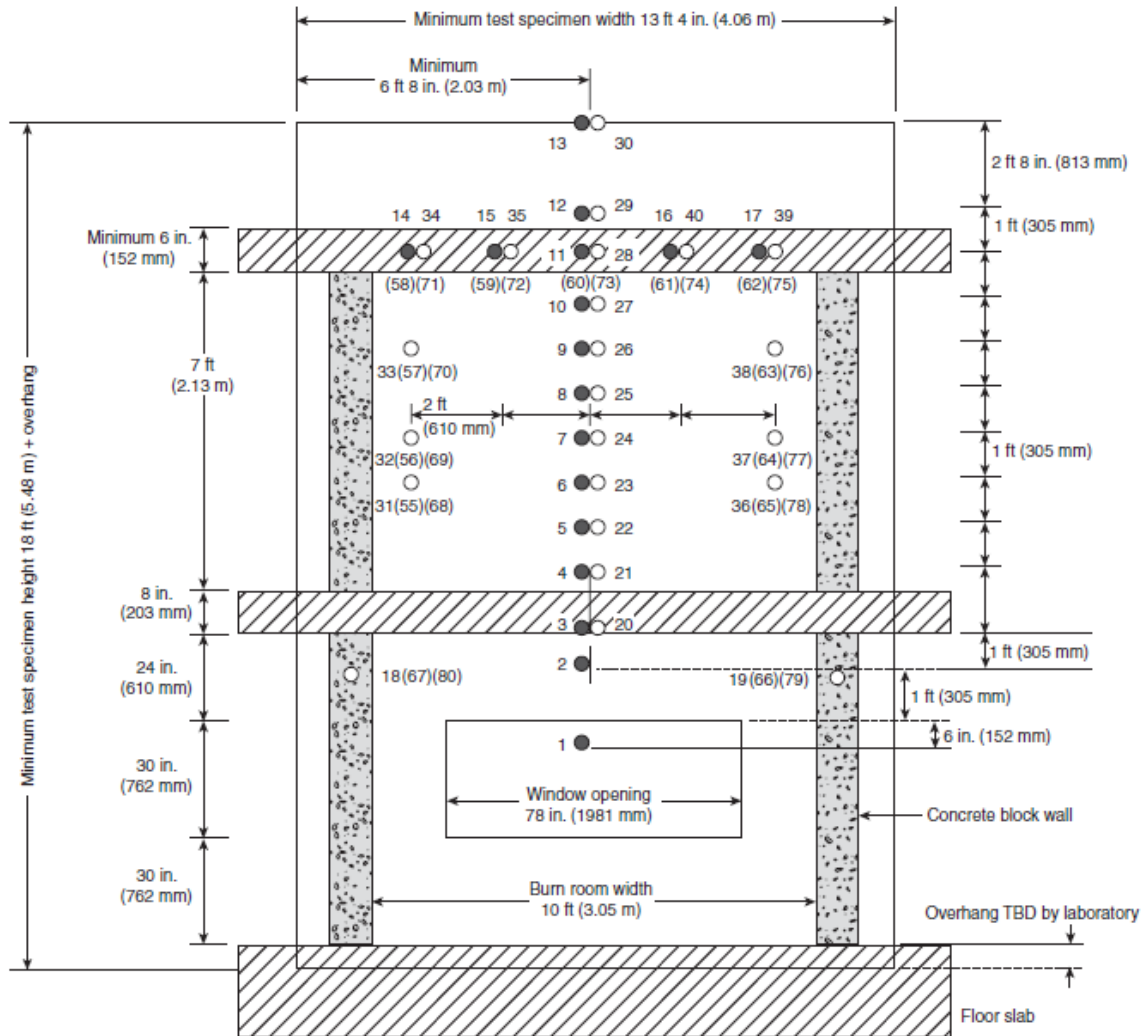
### Standard TC Locations

- Thermocouples — 1 in. (25 mm) from exterior wall surface
- Thermocouples — In the wall cavity air space or the insulation, or both, as shown in Figure 6.1(b) Details A through I.
- ( ) Thermocouples — Additional thermocouples in the insulation or the stud cavity, or both, where required for the test specimen construction being tested, as shown in Figure 6.1(b) Details C through I.

The wall assembly was instrumented with thermocouples (TCs) in accordance with figures 6.1(a) and 6.1(b) of NFPA 285 test method. 16-GA Type K TCs were used in the burn room and 24-GA Type K were used on exterior façade and cavity air space. The window burner was positioned in the center of the opening and 4 in. off the exterior face of the wall assembly. Testing was performed on November 12, 2019 in accordance with NFPA 285 test method. Ambient conditions were 56°F and 18% relative humidity. Video recording, digital photographs, visual observations, and data collection were performed prior, during, and after testing was completed. Temperature data was recorded every 15 seconds. The test was performed at 08:59 AM with the burners on for 30 minutes. All observations are recorded in the table located in Section 8.
