REPORT NUMBER: 3196773TOR-009 ISSUE DATE: October 15, 2010

PRODUCT EVALUATED: Wall Assembly Test Frames EVALUATION PROPERTY: Structural Performance

Report for National Gypsum Company of assembly and test witnessing of test frames for structural performance conducted in accordance with a modified ASTM E330-02, "Standard Test Method for Structural Performance of Exterior Windows, Doors, Skylights and Curtain Walls by Uniform Static Air Pressure Difference"

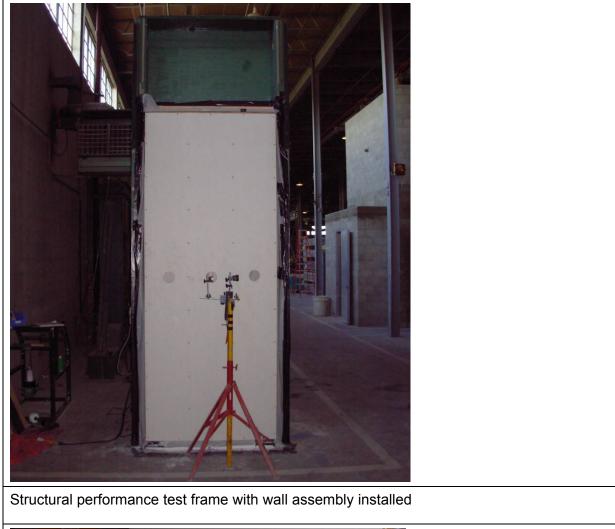
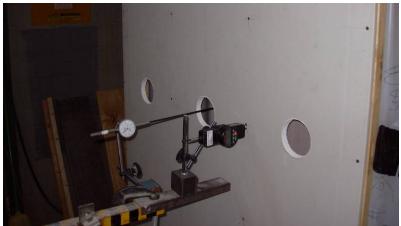
Gage locations on test wall assembly. One gage on back of wall assembly and one gage on back of plywood/fiberglass gypsum sheathing
